Manhole Inspection Summary

Manhole # S67K__004MH

Insp Date: **11/25/08 1:53 PM**

Location Address: **750 Kane St.**

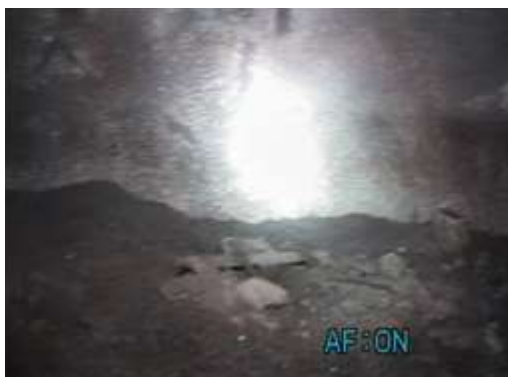
Defect 3

Debris on bench up close

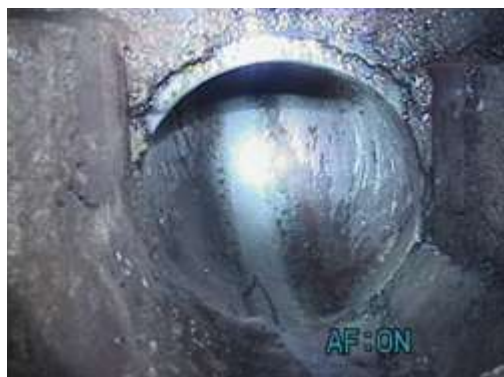
Defect 4

Cracked pipe seal 10 to 12 incoming 3 drop

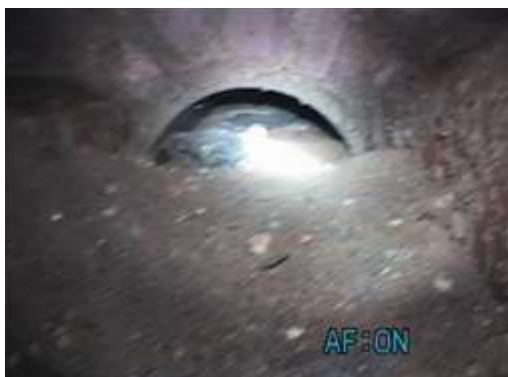
Defect 1

Debris in channel in front of I6

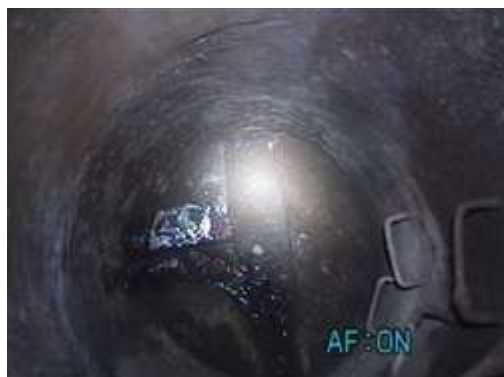
Defect 2

Debris on bench

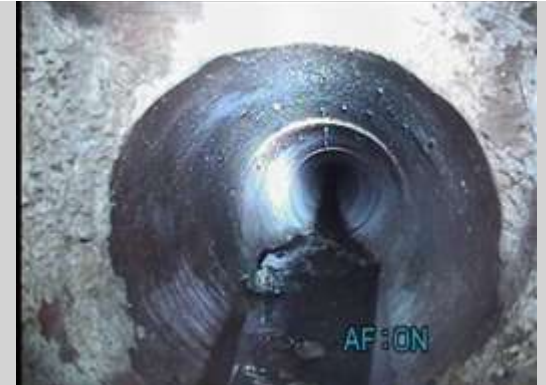
12 O'Clock Outflow

10 in. Circular Gravity Sewer
Pipe Out @ 12 O'Clock

Pipe Height: **10.8** (in.) Rod and Bar (Angled)
Pipe Material: **Clay** ☐ Pipe Lined
Invert Depth: **13.33** (ft.) Flow Characteristics: **Slow**
Deposits: ☐ None ☒ **Mud** ☒ **Sludge** ☐ **Debris** ☐ Grease
Silt Depth: **0.25** (in.) Deposits Extent: **Light**
Infiltration: **None** Pipe Seal Cond: **Sound**

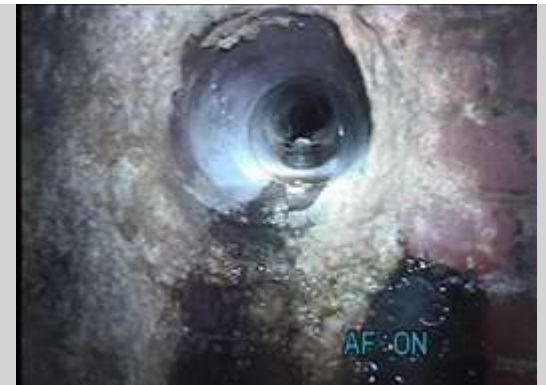
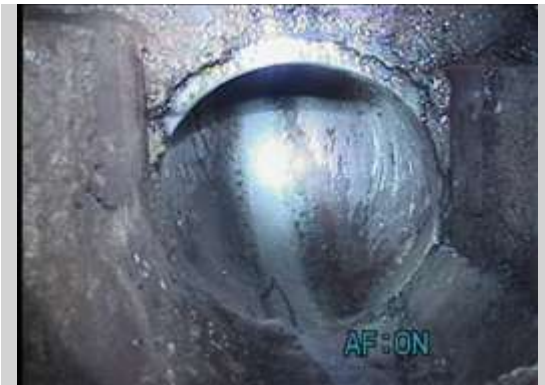
3 O'Clock Inflow

8 in. Circular Gravity Sewer
Pipe In @ 3 O'Clock

Drop In @ 3 O'Clock

Pipe Height: **8.4** (in.) Rod and Bar (Angled)
Pipe Material: **Clay** ☐ Pipe Lined
Invert Depth: **9.75** (ft.) Flow Characteristics: **Slow**
Deposits: ☒ None ☐ **Mud** ☐ **Sludge** ☐ **Debris** ☐ Grease
Silt Depth: (in.) Deposits Extent:
Infiltration: **None** Pipe Seal Cond: **Cracked**

Drop: **Outside** Rod and Bar
Angled: **Yes** Reading: **12.10** (ft.)
Inv Depth: **13.10** (ft.)

Drop Condition: **Open**

Connects To: **Dead End**

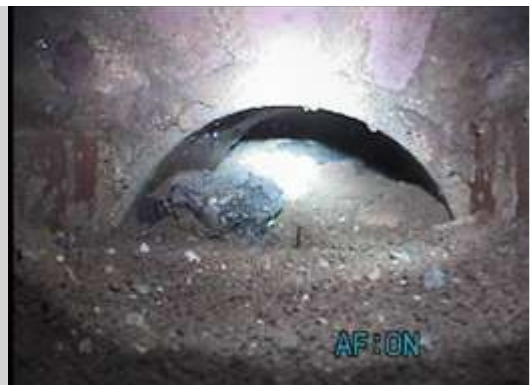
6 O'Clock Inflow

10 in. Circular Gravity Sewer
Pipe In @ 6 O'Clock

Pipe Material: **Unknown** ☐ Pipe Lined

Invert Depth: **12.75** (ft.) Flow Characteristics: **None**

Deposits: ☐ None ☒ **Mud** ☒ **Sludge** ☒ **Debris** ☐ Grease

Silt Depth: **6** (in.) Deposits Extent: **Heavy**

Connects To: **Stub connection / abandoned**
